DEPARTMENT OF TRANSPORTATION**DIVISION OF ENGINEERING SERVICES**

Contract #: 04-0120F4Cty: SF/ALA Rte: 80 PM: 13.2/13.9File #: 1.28**WELDING INSPECTION REPORT****Resident Engineer:** Casey, William**Address:** 333 Burma Road**City:** Oakland, CA 94607**Report No:** WIR-028283**Date Inspected:** 28-Aug-2012**Project Name:** SAS Superstructure**OSM Arrival Time:** 700**Prime Contractor:** American Bridge/Fluor Enterprises, a JV**OSM Departure Time:** 1930**Contractor:** American Bridge/Fluor Enterprises, a JV**Location:** Job Site

Caltrans Office of Structural Material (OSM) Quality Assurance Inspector (QAI) Joselito Lizardo was present at the Self Anchored Suspension (SAS) job site as requested to perform observations on the welding of components for the San Francisco Oakland Bay Bridge (SFOBB) Project.

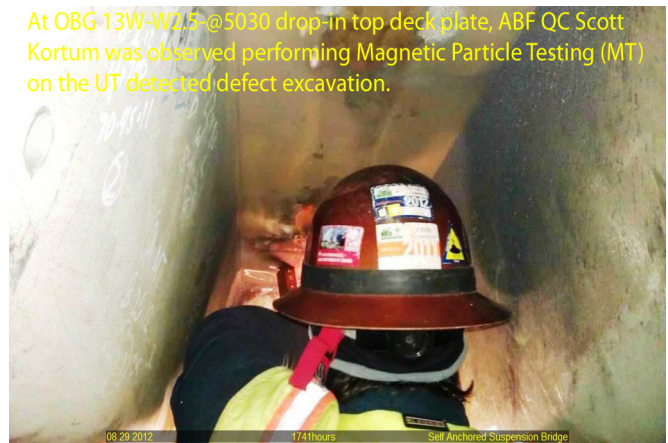
At OBG 13W-W2.5-@5030 drop-in top deck plate, ABF QC Scott Kortum was observed performing Magnetic Particle Testing (MT) on the UT detected defect excavation.
